NASA TN D-1880

EFFECT OF TWO BRAZE COATINGS,
PROCESSING VARIABLES, AND HEAT
TREATMENTS ON 1200° F STRESS-
RUPTURE STRENGTH OF L-605,
A-286, AND INCONEL 700 SHEET

by John H. Sinclair and Charles A. Gyorgak

*Lewis Research Center
Cleveland, Ohio*

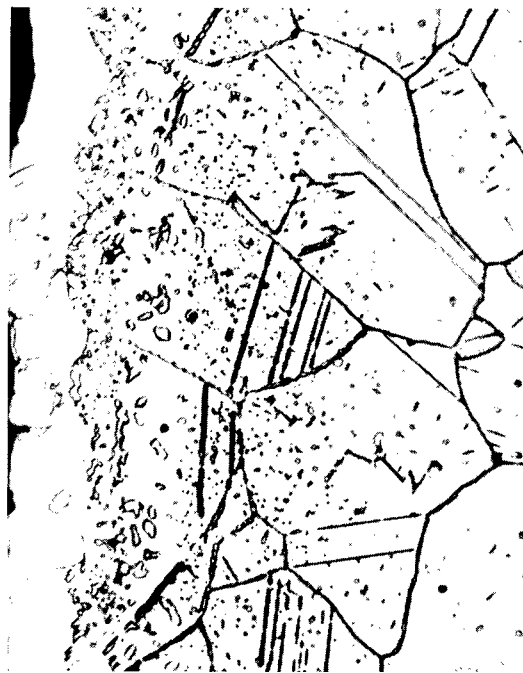
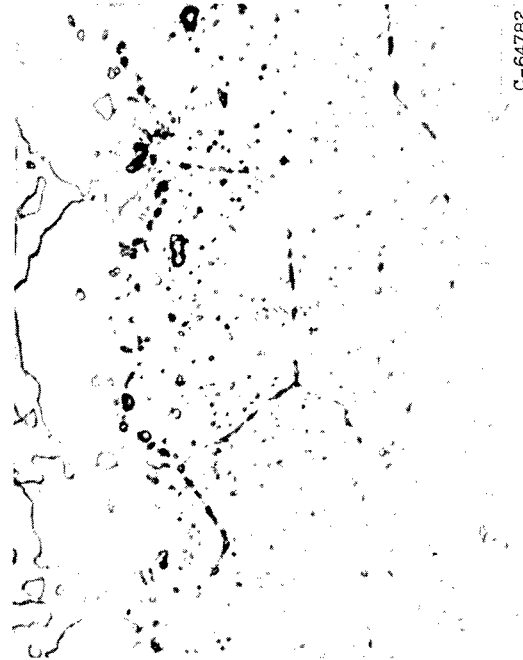
(a) As-received.

(c) NiCrSiB coated at 2075° F for 15 minutes.

(b) Braze-temperature-cycled at 2075° F for 15 minutes.

(d) NiCrSi coated at 2075° F for 15 minutes.

Figure 10. - Microstructures of L-605 stress-rupture specimens prior to testing. Electrolytically etched in a solution of 70 parts saturated boric acid solution, 30 parts 5 percent sulfuric acid solution. X900.

Comparative photomicrographs of specimens braze-temperature-cycled at these two temperatures are given in figures 10(b) and 13. Even though the specimen in figure 13 had been stress-rupture tested 3.8 hours, no significant metallographic differences were noted.

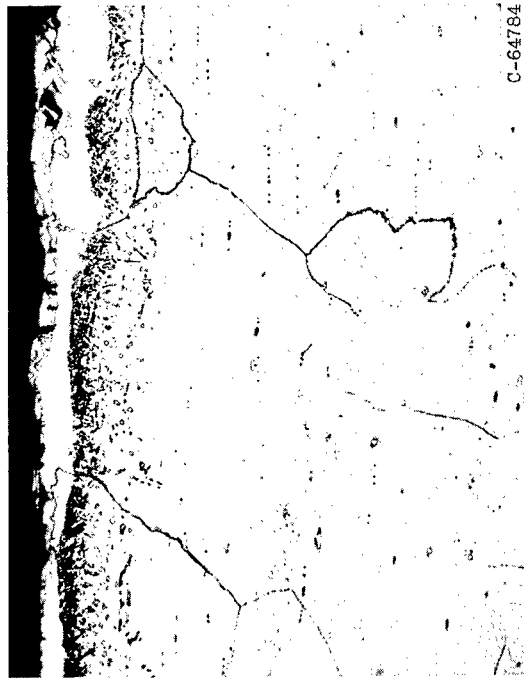
(a) Solution treated; operated 32.8 hours. Etched in glycerine - aqua regia.

(b) Solution treated and braze-temperature-cycled (20750 F) for 15 minutes; operated 3.5 hours. Etched in glycerine - aqua regia.

(c) Solution treated and NiCrSiB coated at 20750 F for 15 minutes. C-64784

Figure 12. - Microstructures of L-605 stress-rupture specimens. Solution treated at 2250° F for 30 minutes. Electrolytically etched in aqua regia in glycerine or solution of 70 parts saturated boric acid solution, 30 parts 5 percent sulfuric acid solution. X250.
